**TEST REPORT**

**Report No.:** C1173.01-109-44

ORCA MANUFACTURING, INC.  
dba Starlight Skylights  
Hurlock, Maryland

**PRODUCT TYPE:** Fixed Curb Mount Impact Modified Skylight  
**SERIES/MODEL:** CM-IMA

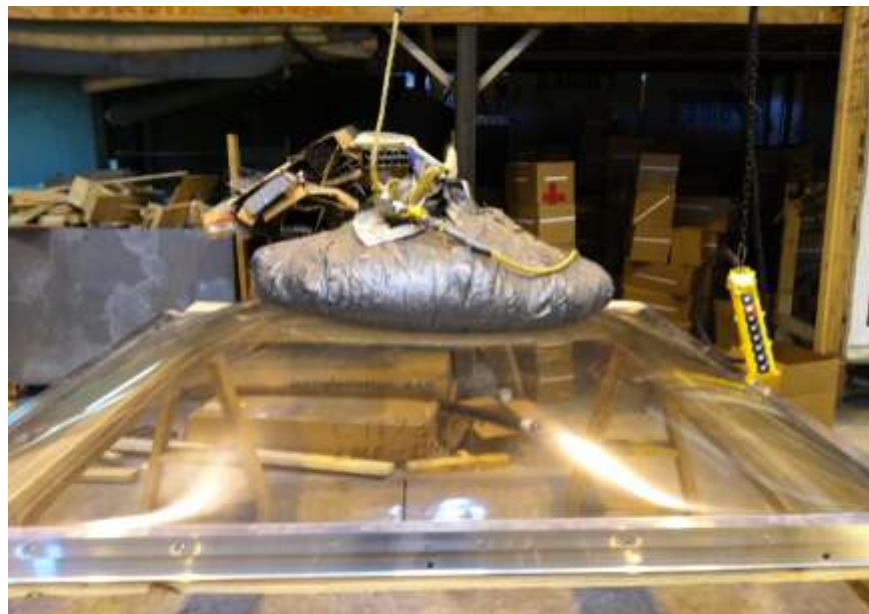
*Note: The 200 lbf weight was gently applied perpendicular to the center of each dome. After 60 seconds of rest time, there was no visible damage to either skylight.*

**Photo No. 2**  
**CM-IMA (200 LB at rest)**

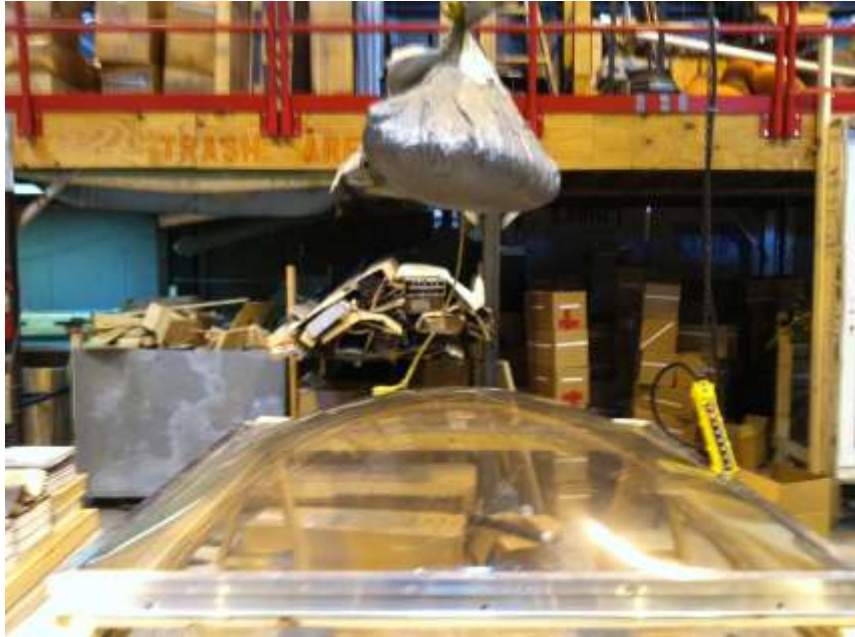
**Photo No. 3**  
**CM-IMA (2') (400 LB-FT)**

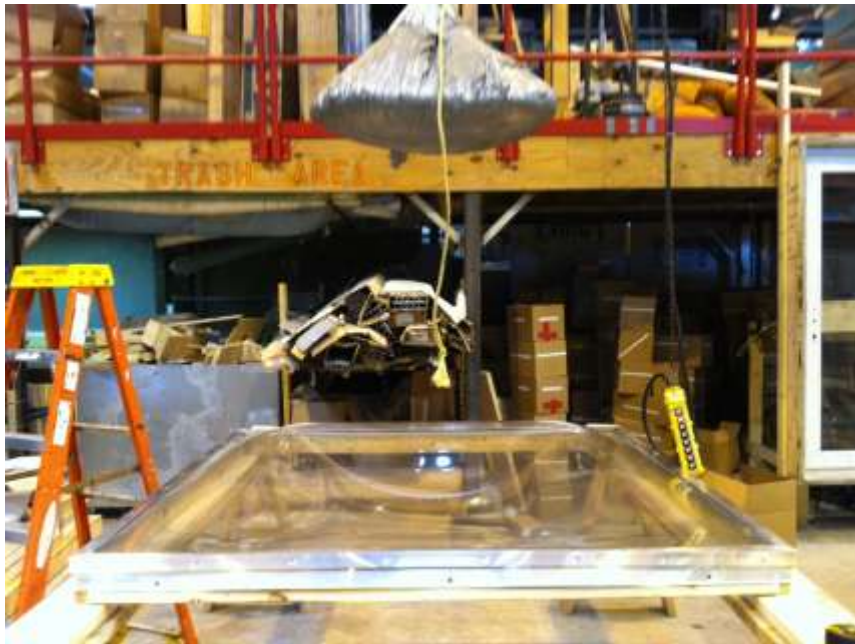
*Note #1: At the 4' drop height, the impact modified acrylic dome pulled out of frame. The bag did not fall through the opening.*

**Photo No. 4**  
**CM-IMA (4') (800 LB-FT)**

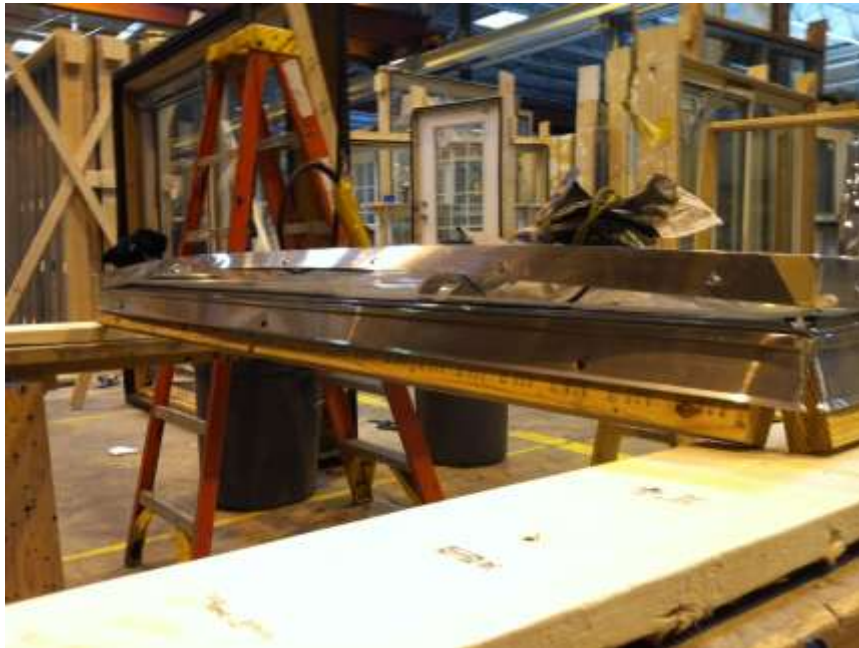
**Photo No. 5**  
**CM-IMA (Failure)**
