**TEST REPORT**

**Report No.:** B9924.01-109-44

**PRODUCT TYPE:** Fall Guard/Security Grill  
**SERIES/MODEL:** FGSG

**SPECIFICATION:** Occupational Safety and Health Administration/U.S. Department of  
Labor Regulations (Standards- 29 CFR)- 1910.23(e)(8).

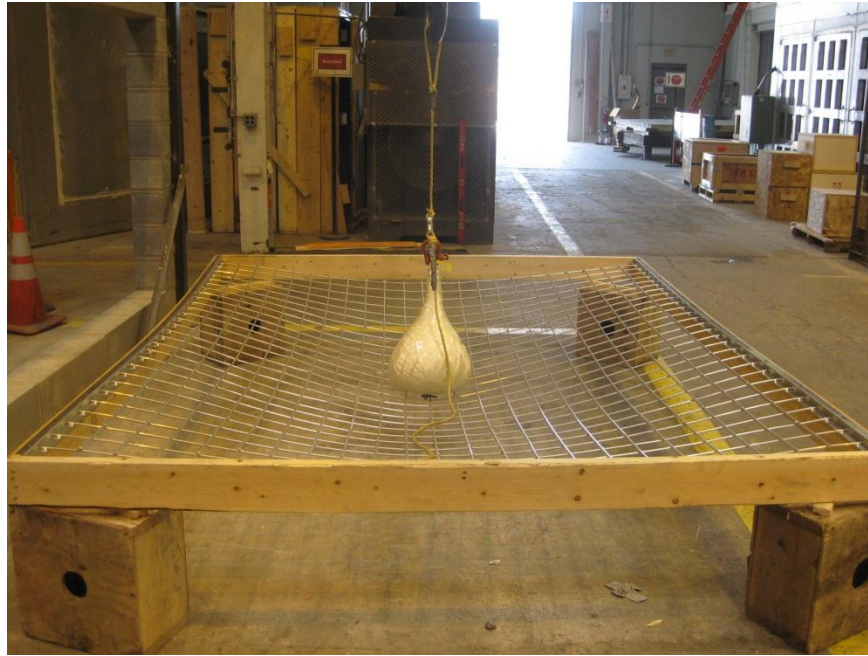
Test	Load Location	Results
200 lbf	Center of guard/grill	No visible damage

*Note: The 200 lbf weight was gently applied perpendicular to the center of the sample. After 60 seconds of rest time, there was no visible damage to either skylight.*

**Photo No. 3**  
**200 lb Static Load**

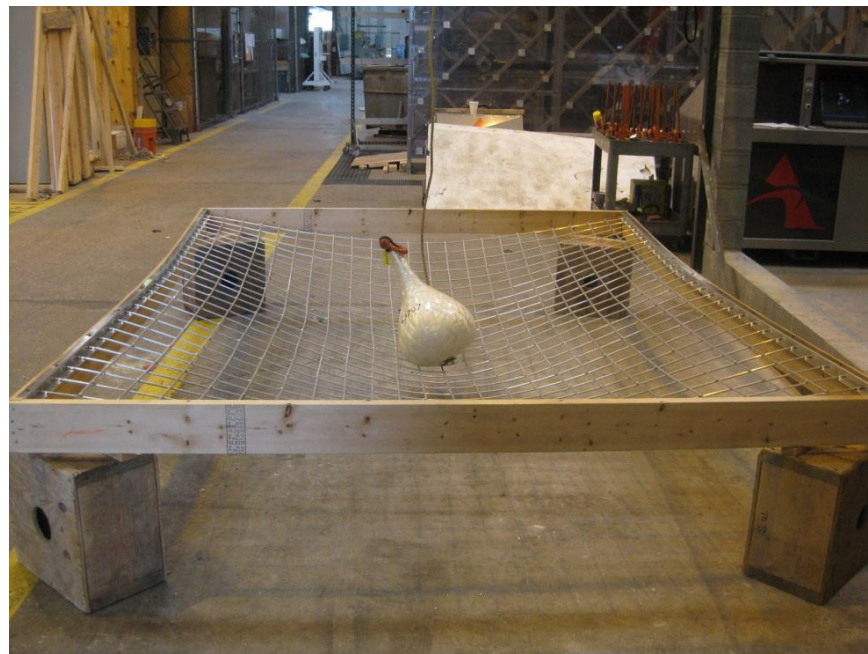
**Photo No. 4**  
**After 2 ft. Drop**

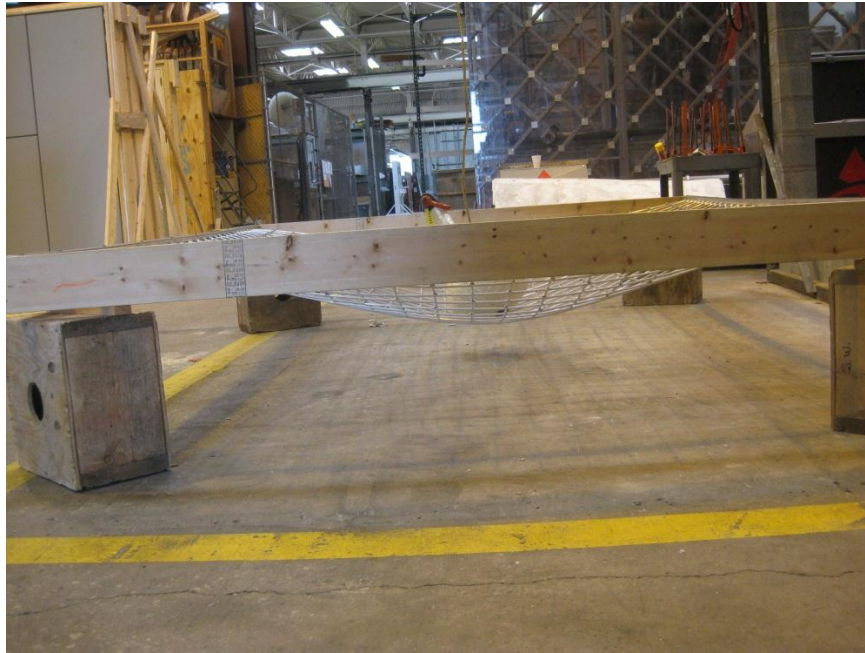
**Photo No. 5**  
**After 2 ft. Drop**

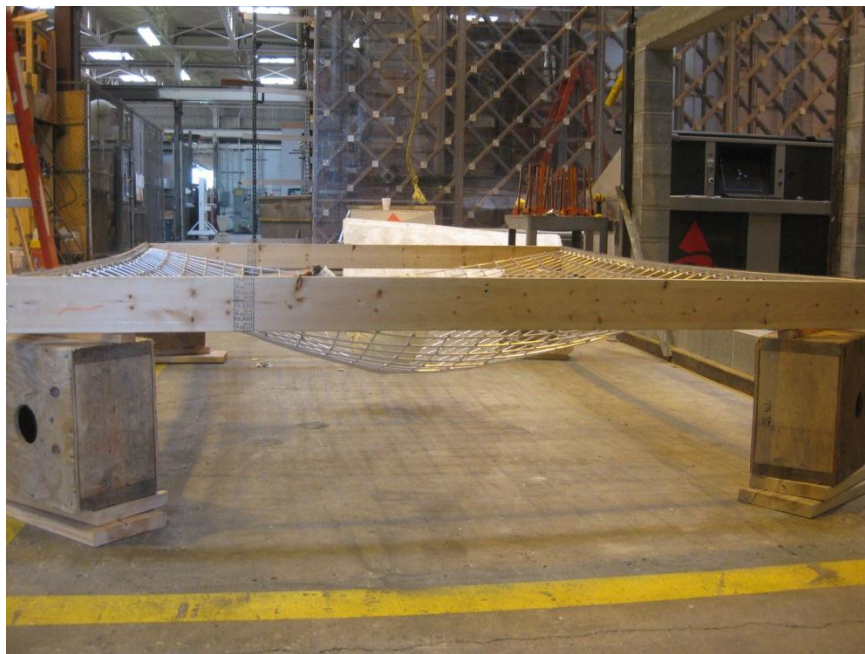
*Note #1: At the 4' drop height, the wood test buck bowed and cracked at the midspan and two welds broke at the impact location. The impact bag did fall through the test specimen.*

**Photo No. 6**  
**After 4 ft. Drop**

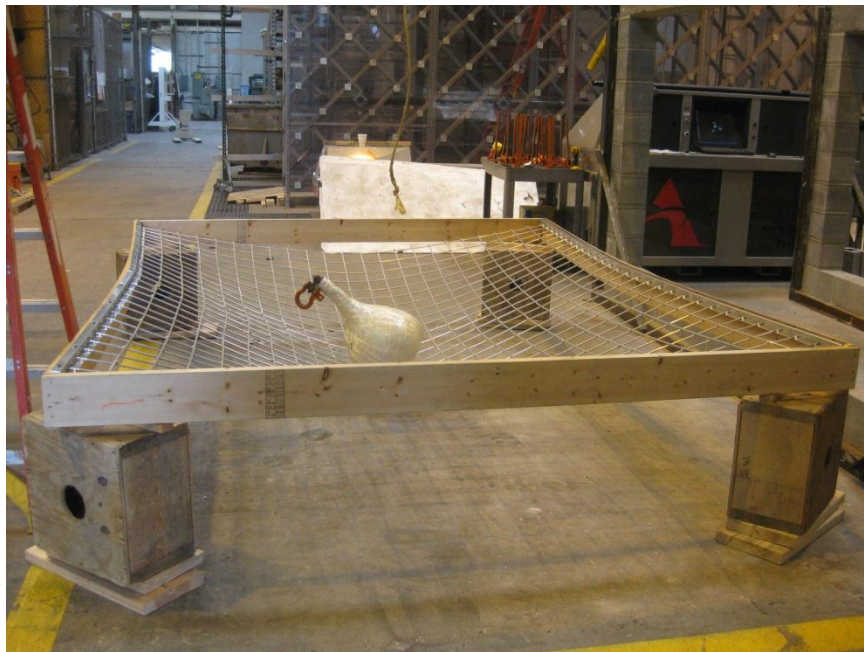
**Photo No. 7**  
**After 4 ft. Drop**
